MARINE INVESTIGATION REPORT
M99W0078

STRIKING

TUG *SHEENA M* AND CHIP BARGE *RIVTOW 901*

**CPR MISSION RAILWAY BRIDGE, FRASER RIVER
MISSION, BRITISH COLUMBIA**

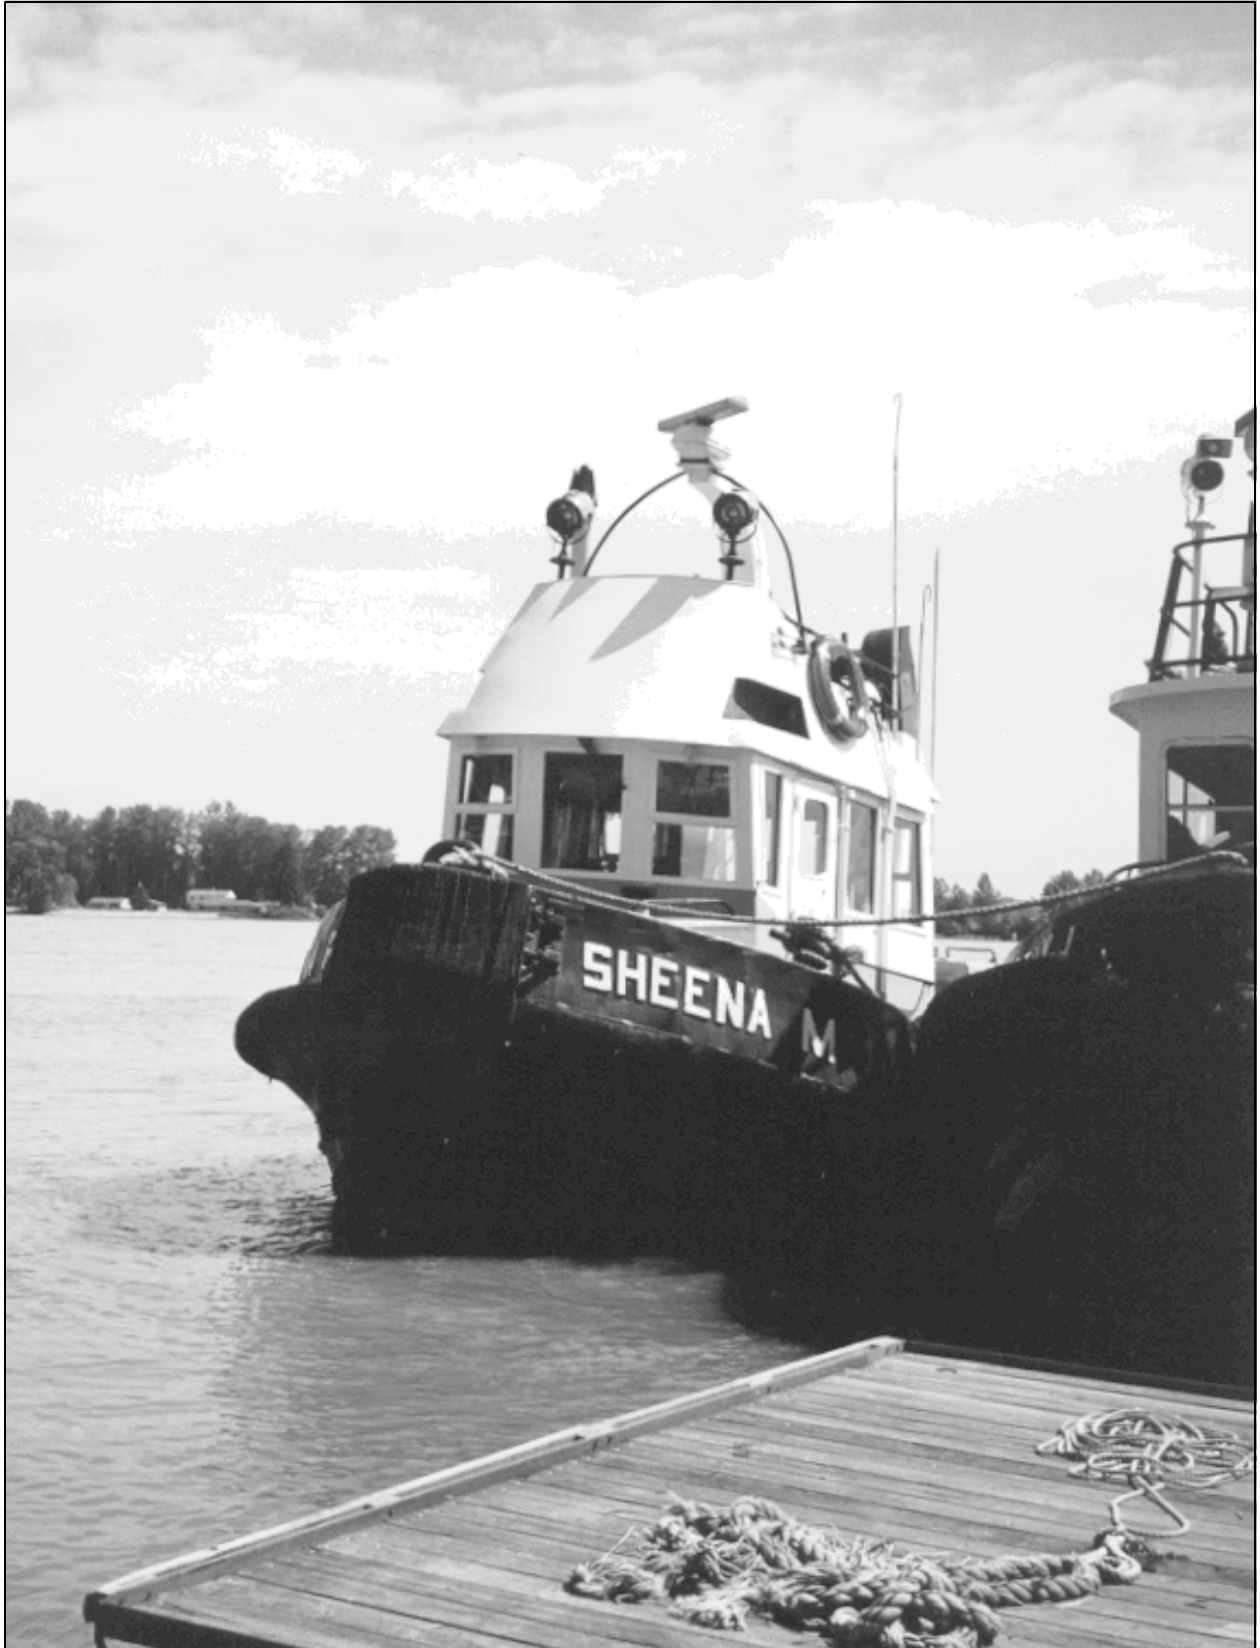
Damage to the tug was minimal. The low-voltage overhead cable spanning the draw was designed to provide an advertised clearance of 21 m above chart datum. This became dislodged when the bridge was struck resulting in a significant reduction of clearance. The tug's main mast, fitted with navigation lights and radio antennae, became fouled in this cable after the accident and was carried away (see Figure 2).

Figure 2. The tug *Sheena M* without mast.

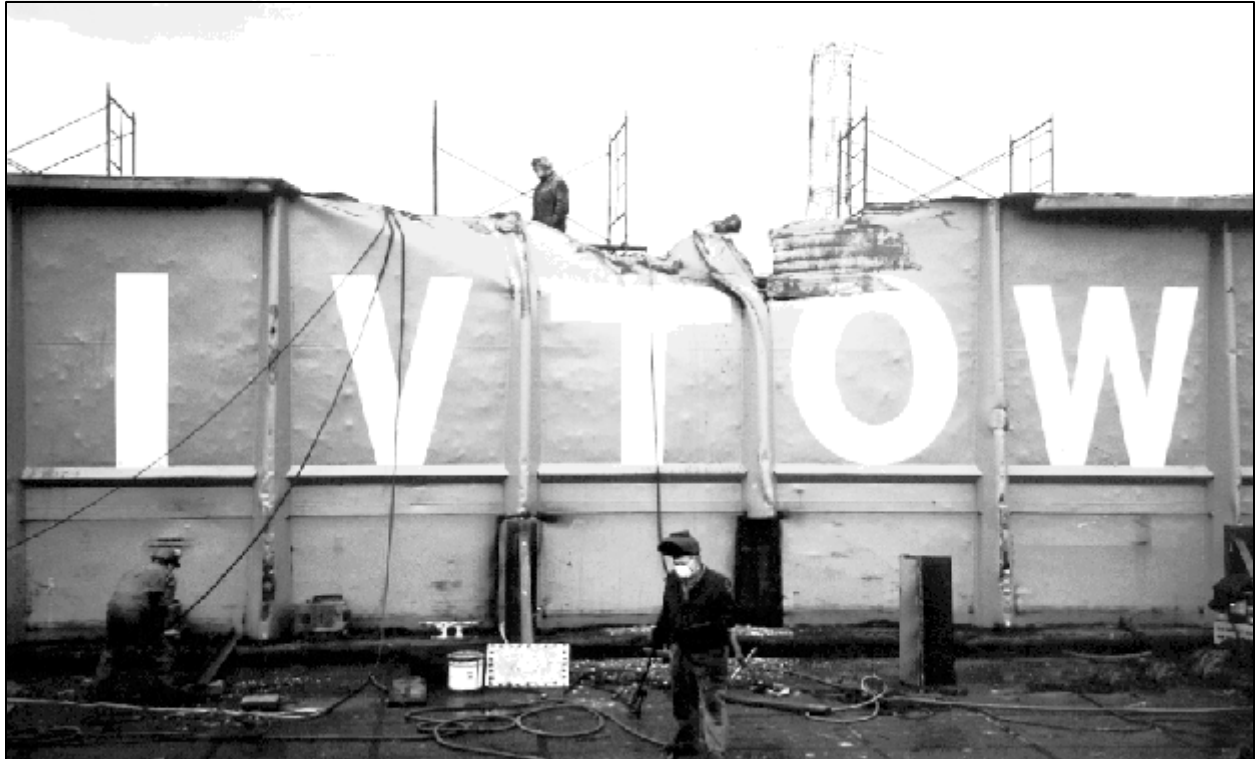
The most significant damage was to the upper edge of the steel box-wall on the starboard side which was fractured and set-in over a length of approximately 6 m at a point immediately forward of the barge's mid-length (see Figure 3). Lesser damage was sustained by the vertical stiffeners welded to the external face of the box-wall. These were damaged to varying degrees, ranging from paint scuffs to, in the case of one stiffener, sufficient deformation to require replacement. The barge's hull remained intact. Only a small amount of the wood chip cargo was spilled onto the bridge or into the river.

Figure 3. The chip barge *Rivtow 901* with damaged starboard box-wall under repairs.

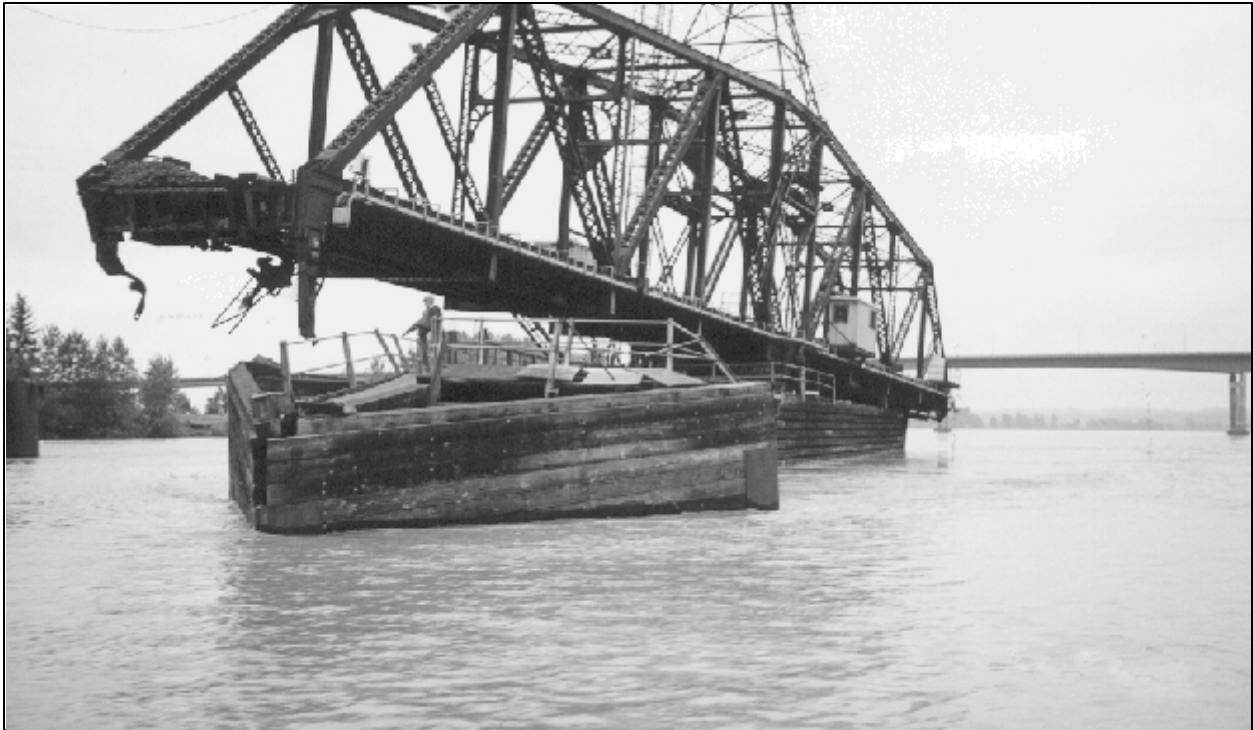
The upstream portion of the bridge protection pier was significantly damaged. As a result of the impact by the barge, the nose of the squared timber (upper) portions of the protection pier was deflected to the north. Without this protection, the swing span was dislodged from its pedestal by the barge impact and deflected approximately 4 m to the west.

Figure 4. Damaged nose of protection pier deflected to north.

Due to the height of the river (4.6 m above chart datum), at the time of the accident approximately 2 m of the upper squared timber portion of the protection pier was visible above the river surface. When the upper portion of the protection pier was struck by the barge, metal strapping and bolts, which connect with the wooden piles, distorted or sheared. Other bolts remained intact but were pulled bodily from position. The upper portion of the protection pier broke away from the pilings and was deflected to the north allowing the box-wall of the chip barge to make contact with the swing span of the railway bridge. The barge struck the swing span with a force sufficient to shift the span almost 4 m from its pedestal. Until it was stabilized several days after the accident, there was concern that the swing span might topple into the river.

Following the accident, the bridge was repaired and the upstream portions of its protection pier were repaired and enhanced. In the damaged section, wooden piles were replaced by a combination of steel pipes and “H” beams. The nose of the protection pier was extended approximately 10 m further upstream by the addition of a wooden-sheathed, triangular-shaped steel structure made from 915-mm diameter pipes driven into the river bed. CPR, in its four-year capital program, is budgeting for similar improvements to the downstream portions of the protection pier.

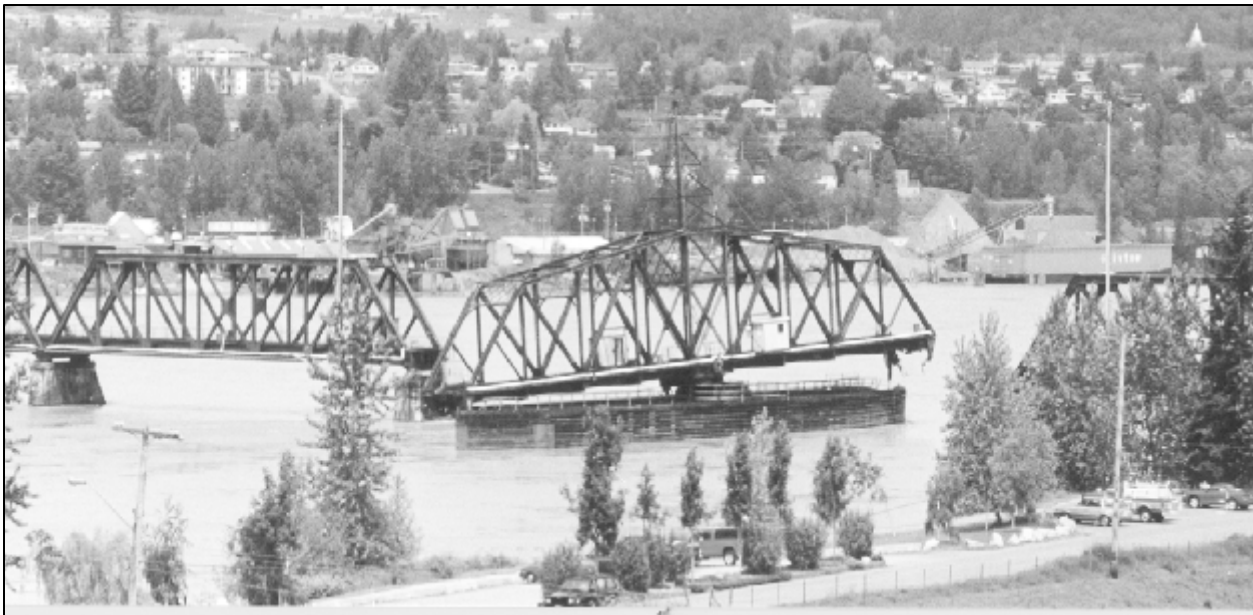
The striking caused considerable damage to the protection pier and swing span of the bridge. Rail traffic over the bridge was interrupted until 30 June 1999.

Figure 5. Damaged CPR Mission Railway Bridge at Mission, B.C., viewed from south shore of Fraser River. Meeker Cedar mill in background with a chip barge at loading facility.
